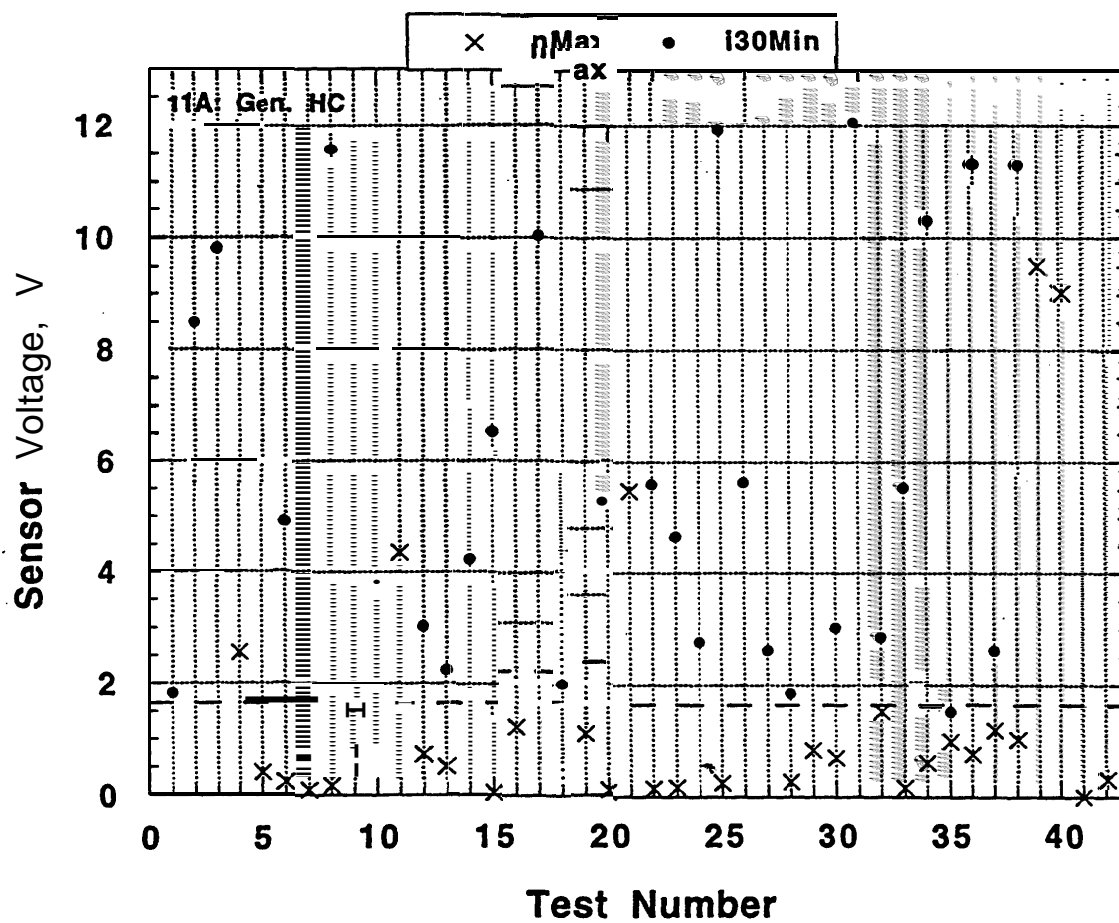
Figure 36. Site 11 general-hydrocarbon sensor maximum normal and minimum ignition output 30 s before ignition versus test number.

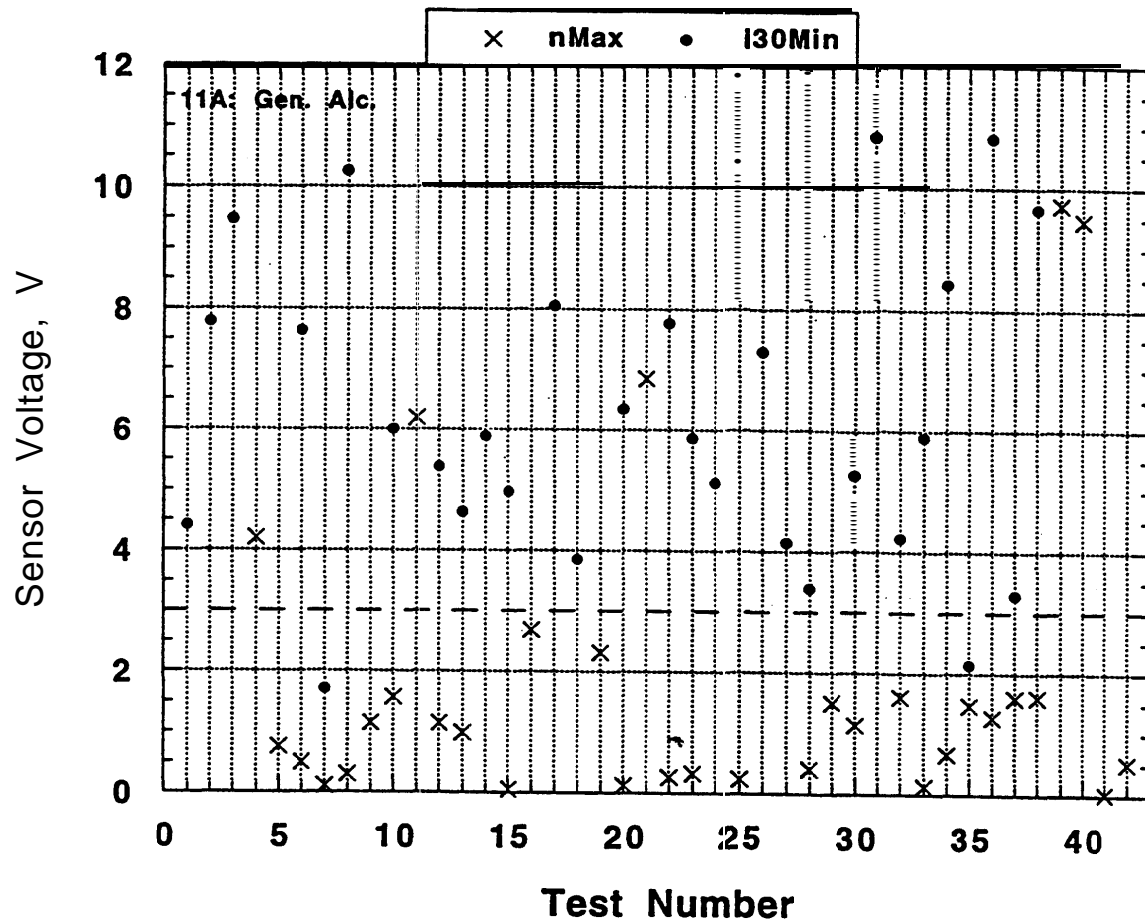
Figure 37. Site 11 general-alcohol sensor maximum normal and minimum ignition output 30 s before ignition versus test number.

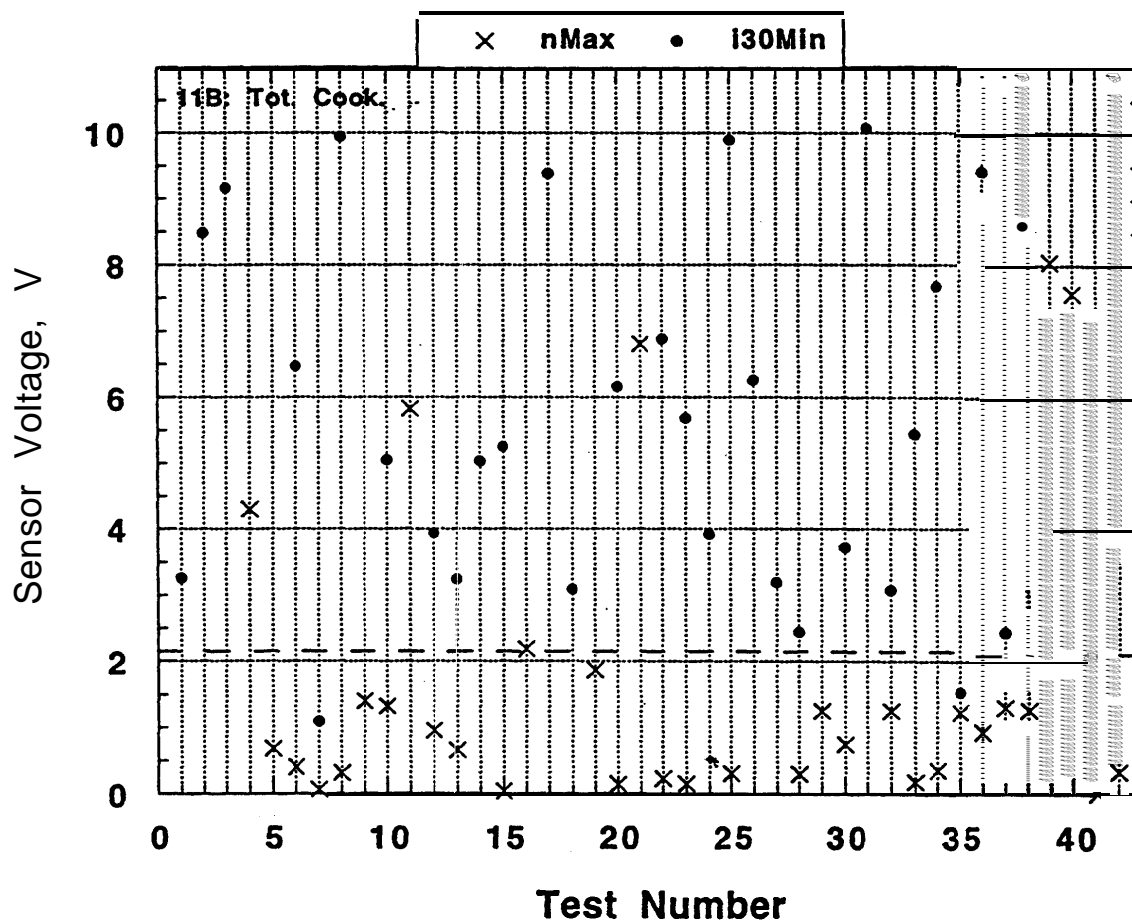
Figure 38. Site 11 total-cooking-gas sensor maximum normal and minimum ignition output 30 s before ignition versus test number.

shift the relative proportions of failures-to-alarm to false alarms. The plot of the responses of the total-cooking-gas sensor in Figure 38 shows that it also would generate the same set of successes and failures as the previous two sensors if an alarm threshold of 2.2 V were used. Figure 39 is the plot for the cooking-alcohol sensor at site 11. If a threshold of 3.5 V is selected, this sensor performs like the other site 11 gas sensors. The responses of the site 11 gas sensors were similar, but the two alcohol sensors produced slightly higher ignition minima and clearer separation from the main group of normal maxima that make them slightly better candidates for detector components.

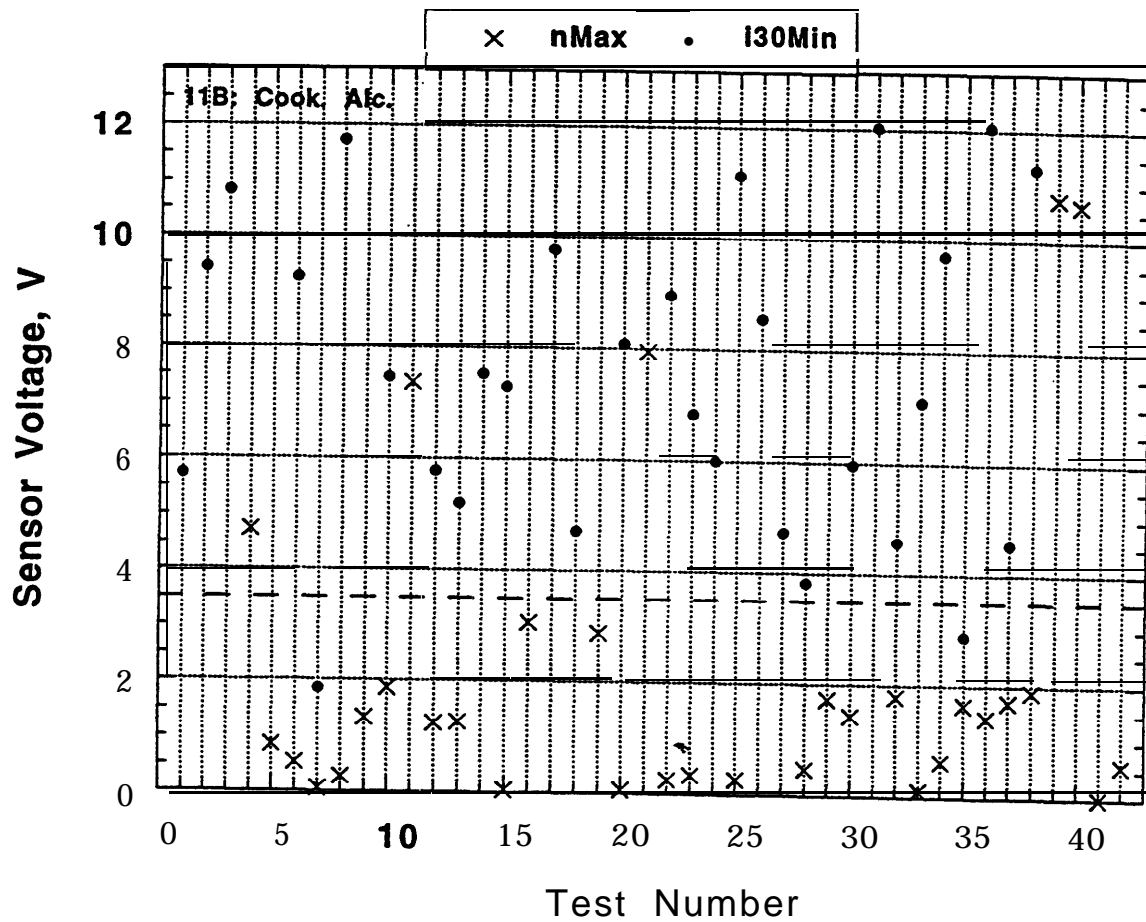
Figure 39. Site 11 cooking-alcohol sensor maximum normal and minimum ignition output 30 s before ignition versus test number.

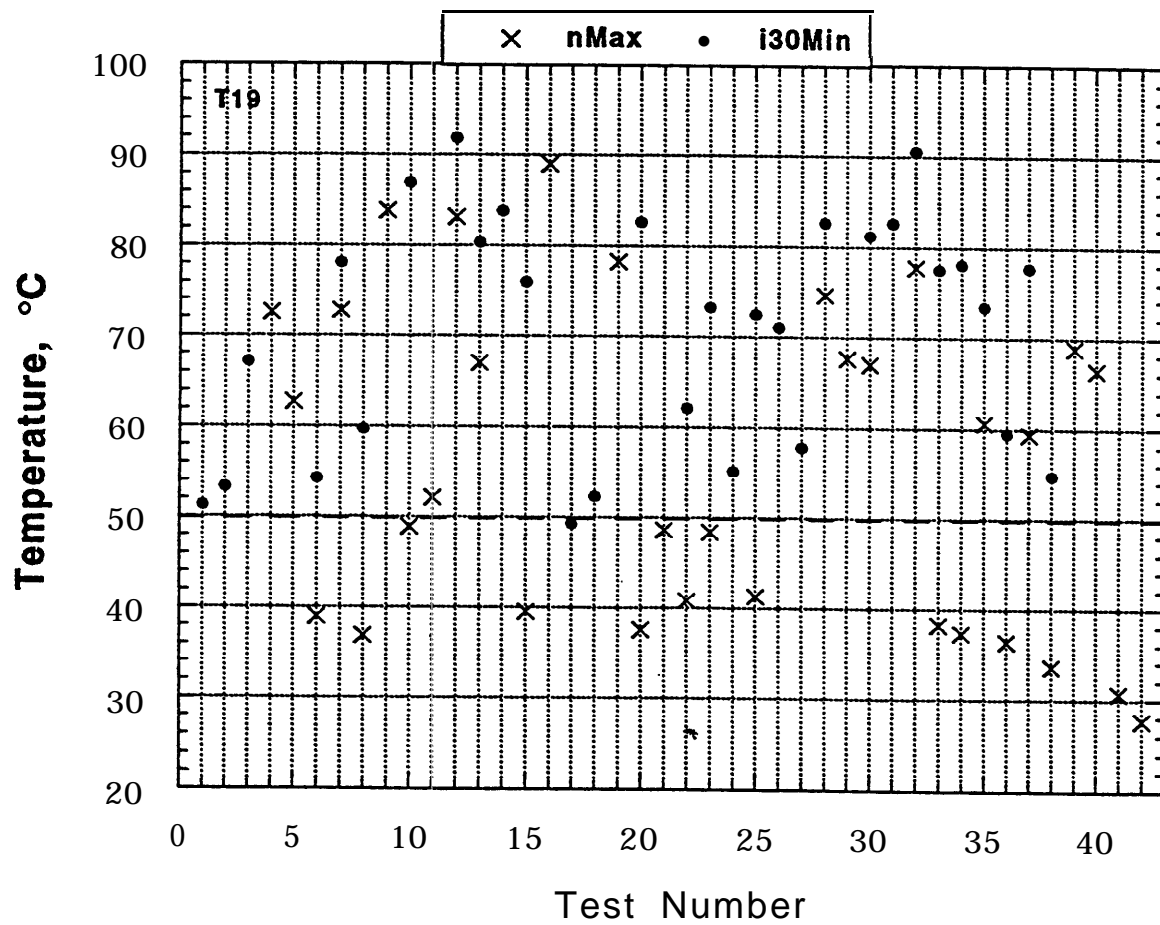
Figure 40. Site 19 thermocouple temperature maximum normal and minimum ignition output 30 s before ignition versus test number.

While many thermocouples showed trends of increasing temperature versus time, only the pan-bottom thermocouple provided adequate distinction between normal and pre-ignition temperatures for multiple tests. Figure 40 shows the response for the site 19 thermocouple which was located at the center of the range **surface**. The temperature at site 19 did not provide clear contrast between normal and pre-ignition conditions. Table 7 lists the site 19 thermocouple **alarm** rates as 3 1% false alarm and 3% failure to alarm. The thermocouples near the heating burner produced the highest range of temperatures and therefore provided the best differentiation. While food temperatures were monitored since ignition is most closely tied to the temperature of the potential fuel and surfaces contacting it, it is impractical to implement food or inside-pan temperature measurements as part of a detection system because they would require action by the cook. The next most logical, **useful** temperature measurement would be underneath the pan bottom.

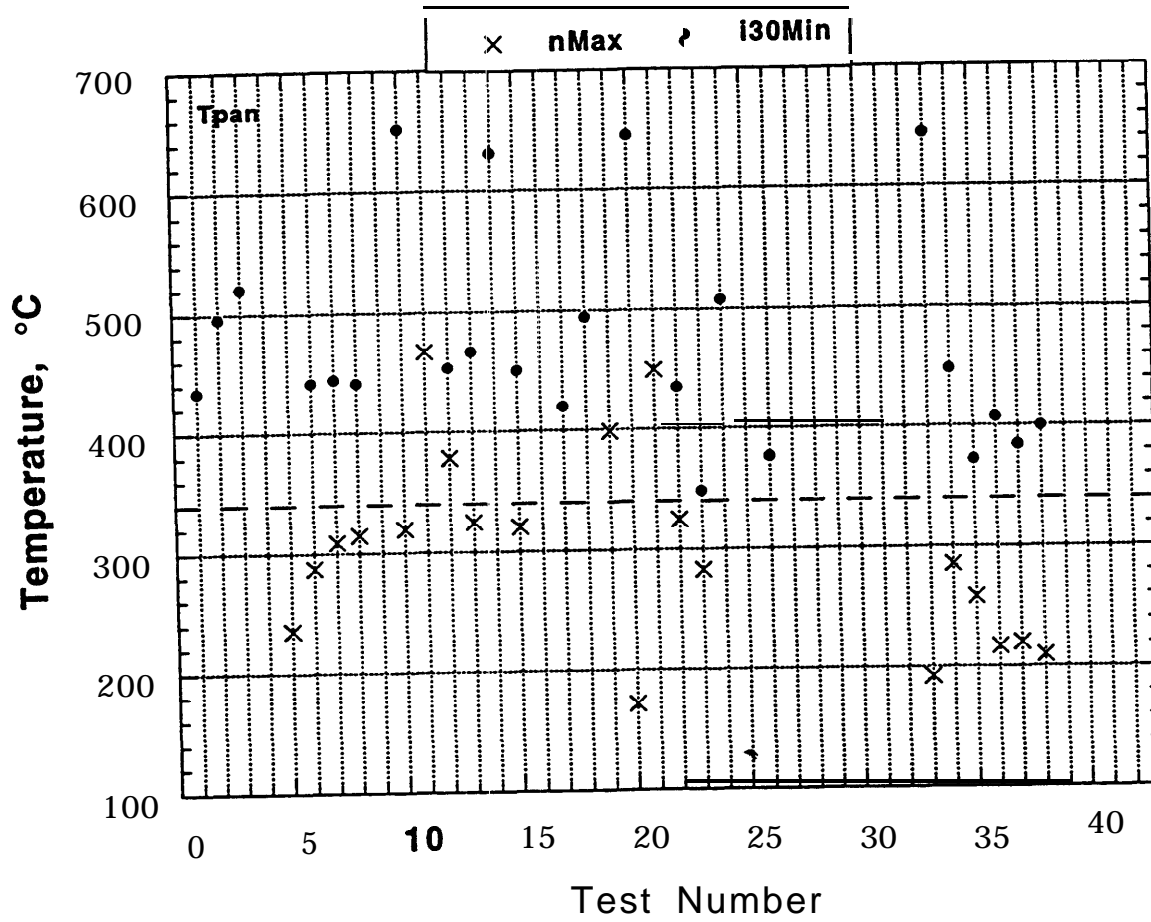
Figure 41. Focus-burner pan-bottom temperature maximum normal and minimum ignition output 30 s before ignition versus test number.

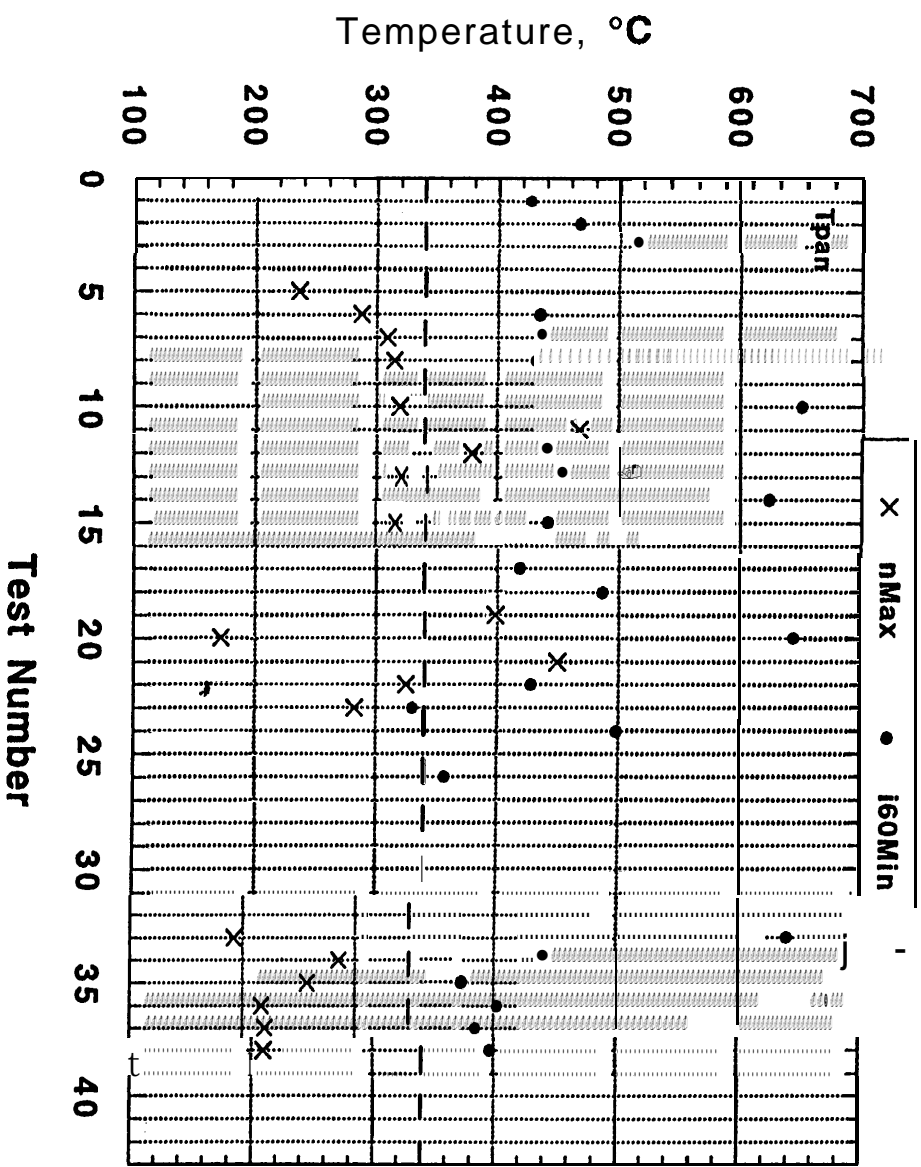
Figure 42. Focus-burner pan-bottom temperature maximum normal and minimum ignition output 60 s before ignition versus test number.

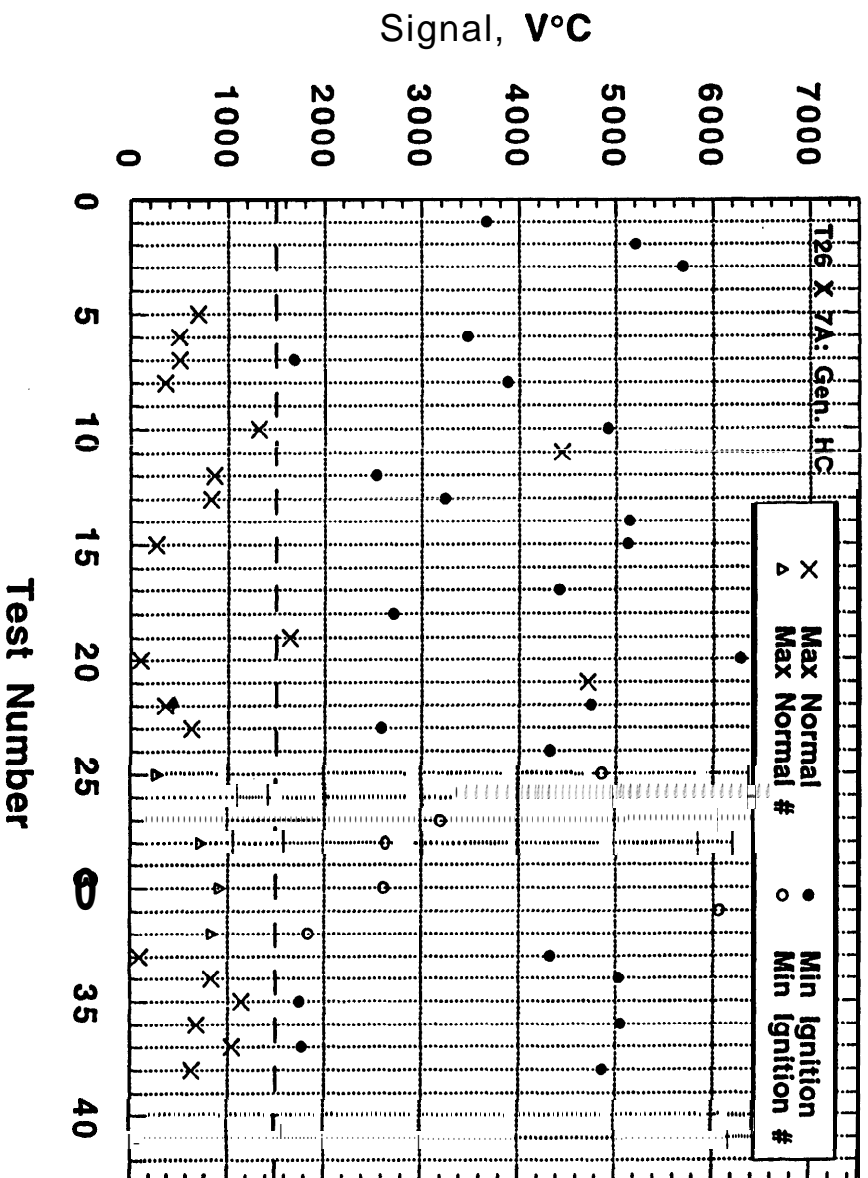
Figure 43. Focus-burner pan-bottom temperature multiplied by site 7 general-alcohol sensor voltage maximum normal and minimum ignition output 30 s before ignition versus test number. # signifies the results from substitute thermocouple data.

Figures 43 - 45 show plots of combined normal maxima and ignition minima for the **pan-bottom** thermocouple and three selected chemical sensors for each test. Note that the triangles and open circles represent substitute **data** that result from combining the sensor data from the tests for which the pan-bottom thermocouple malfunctioned with the functioning-thermocouple results from the duplicate tests for those cases.

Figure 43 is a plot of the results of combining **pan-bottom** temperature and the site 7 **general-alcohol** sensor voltage. A distinct gap with only a couple exceptions exists from 1400 to 1600 **V°C** between the normal and pre-ignition data points. Data from water test 19 has already been described as anomalous since the pan boiled dry. The only remaining exceptions are those from the blackened-catfish tests. Figure 44 is a plot of the result of combining the **pan-bottom** temperature and the site 7 cooking-alcohol sensor voltage. A gap between the conditions exists from 1400 to 1600 **V°C** as well. Figure 45 is the corresponding plot for the pan-bottom temperature and site 9's cooking-alcohol sensor. This combination produces a gap from **1200** to 1500 **V°C**. The condition discrimination produced by these combined-sensor signals is better than those generated by the best single sensors. Figure 46 is the same as Figure 45 except the 60 s before ignition criteria were used to generate the minimum pre-ignition signals. The results are very similar with only a slight decrease in the spread between the normal and pre-ignition

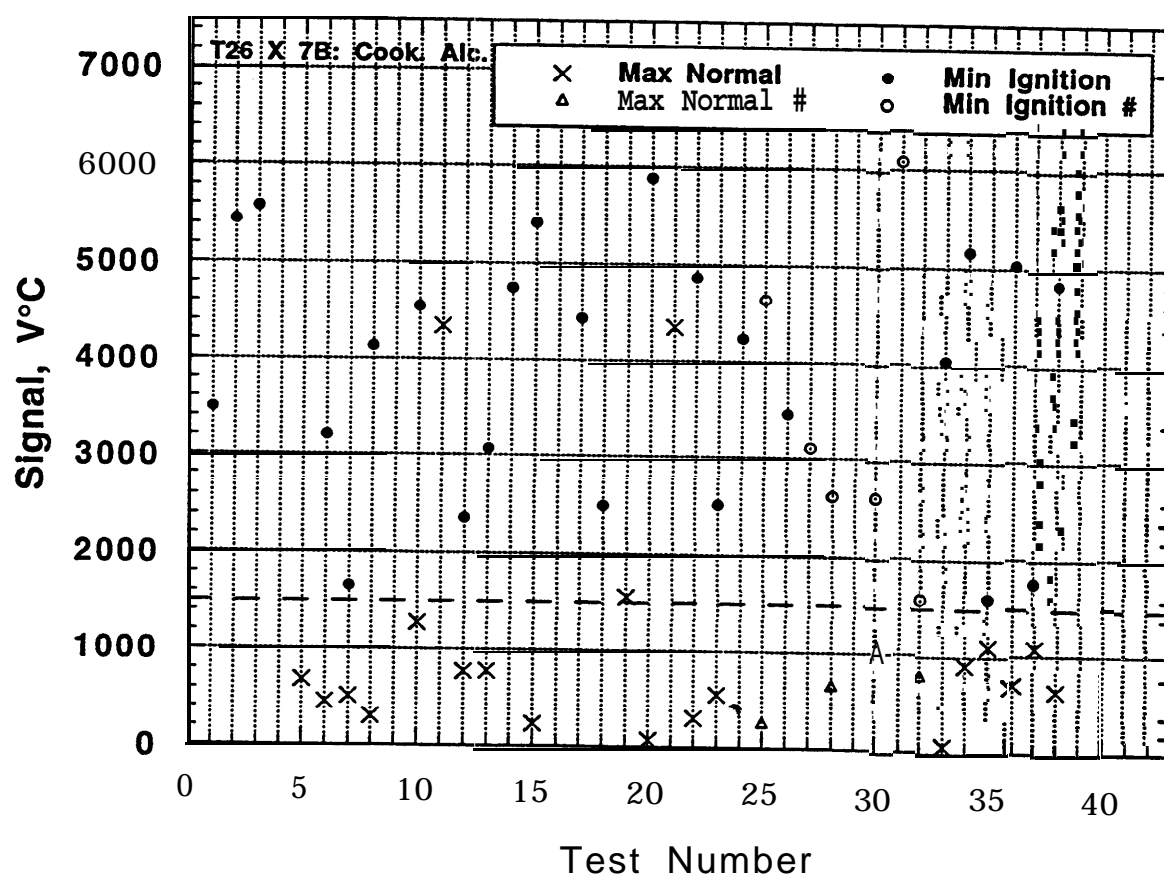
Figure 44. Focus-burner pan-bottom temperature multiplied by site 7 cooking-alcohol sensor voltage maximum **normal** and minimum ignition output 30 s before ignition versus test number. # **signifies** the results from substitute thermocouple data.

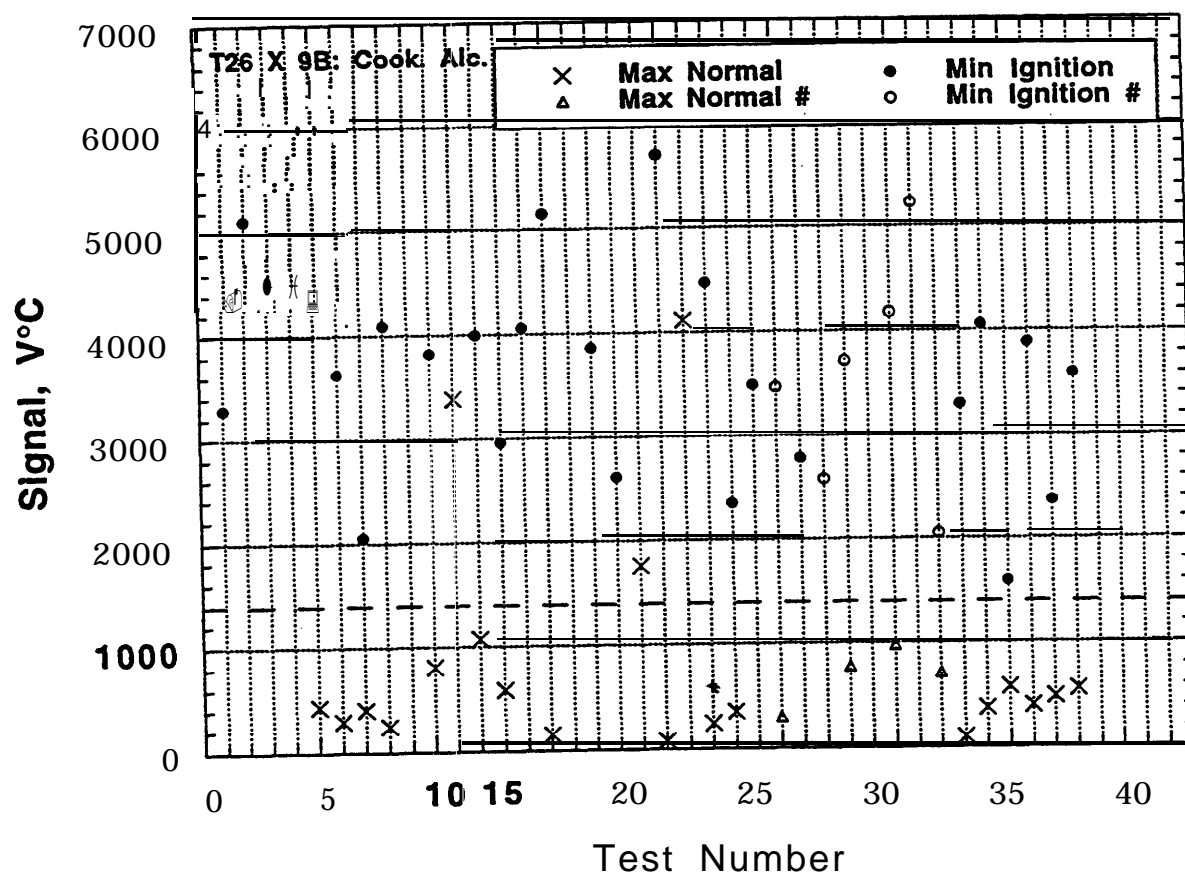
Figure 45. Focus-burner pan-bottom temperature multiplied by site 9 cooking-alcohol sensor voltage maximum normal and minimum ignition output 30 s before ignition versus test number. # signifies the results from substitute thermocouple data.

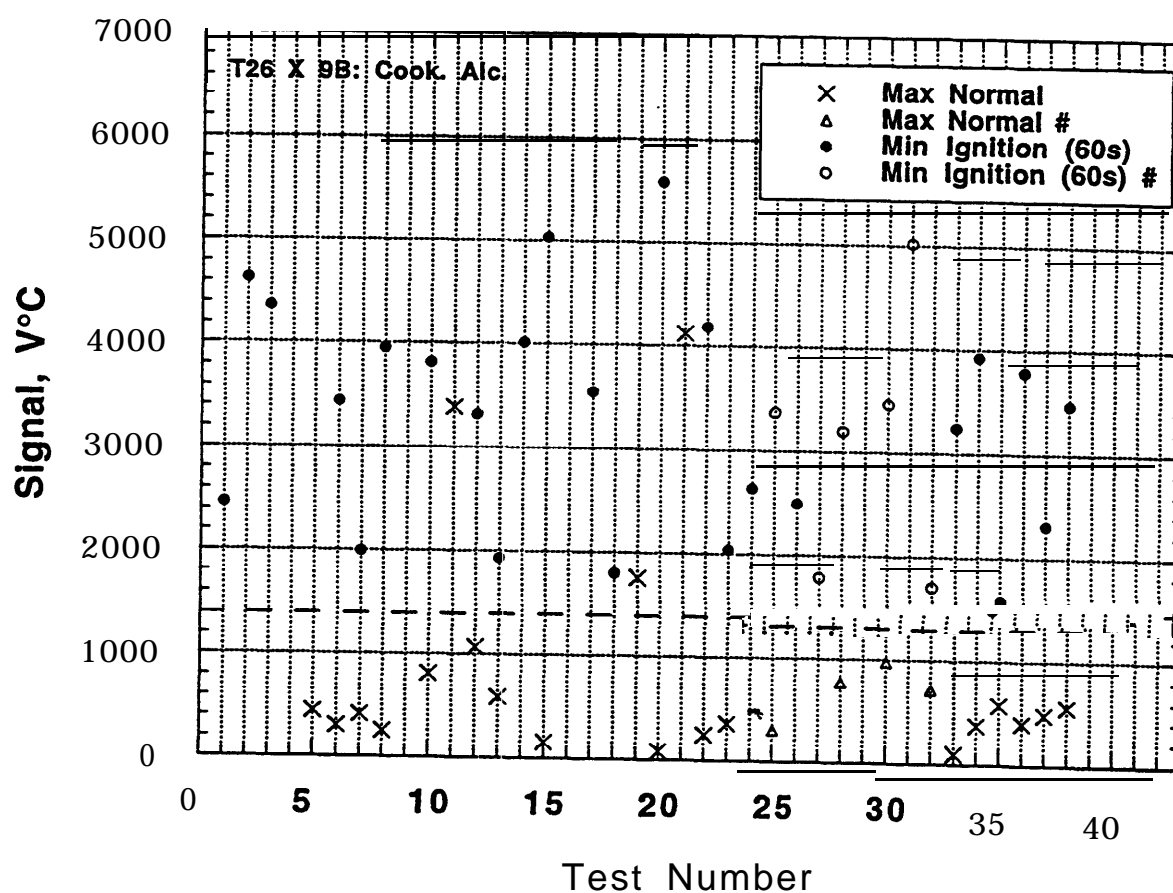
Figure 46. Focus-burner pan-bottom temperature multiplied by site 9 cooking-alcohol sensor voltage maximum **normal** and minimum ignition output 60 s before ignition versus test number. # signifies the results from substitute thermocouple data.

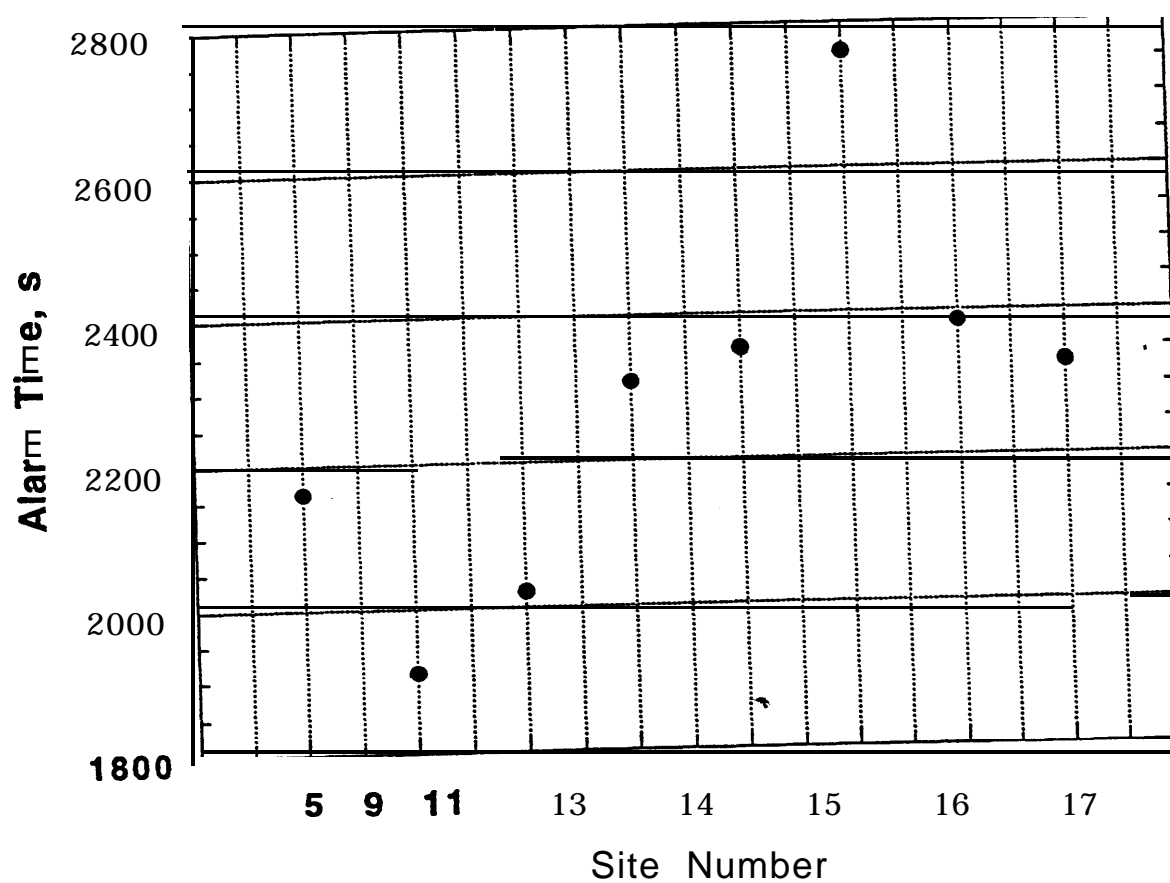
Figure 47. Average photoelectric, smoke-detector alarm time for all tests versus site number.

This section discusses the alarm times generated by photoelectric and ionization smoke detectors at sites 5, 9, 11, and 13-17. Figure 47 is a plot of the average alarm time in seconds versus the individual photoelectric smoke detectors. The earliest alarming detector on average was at site 9 which was located just at the front of the range hood. The site 11 detector was the next most sensitive and was **located** at the ceiling directly above sites 9 and 10 and close to the impingement area of the smoke plumes. The detector at site 5, on the wall under the hood behind the range, was on average the next to respond. Sites 13, 14, 16, and 17 alarmed at similar times, and site 15's photoelectric smoke alarm was the slowest to respond, probably because its location was most distant from the smoke source.

the smoke source and on average, its **photoelectric** detector responded slowest as shown in Figure 47. The site 15 photoelectric detector experienced the fewest false alarms which is consistent with its distance from the smoke source and delay in reacting to the smoke.

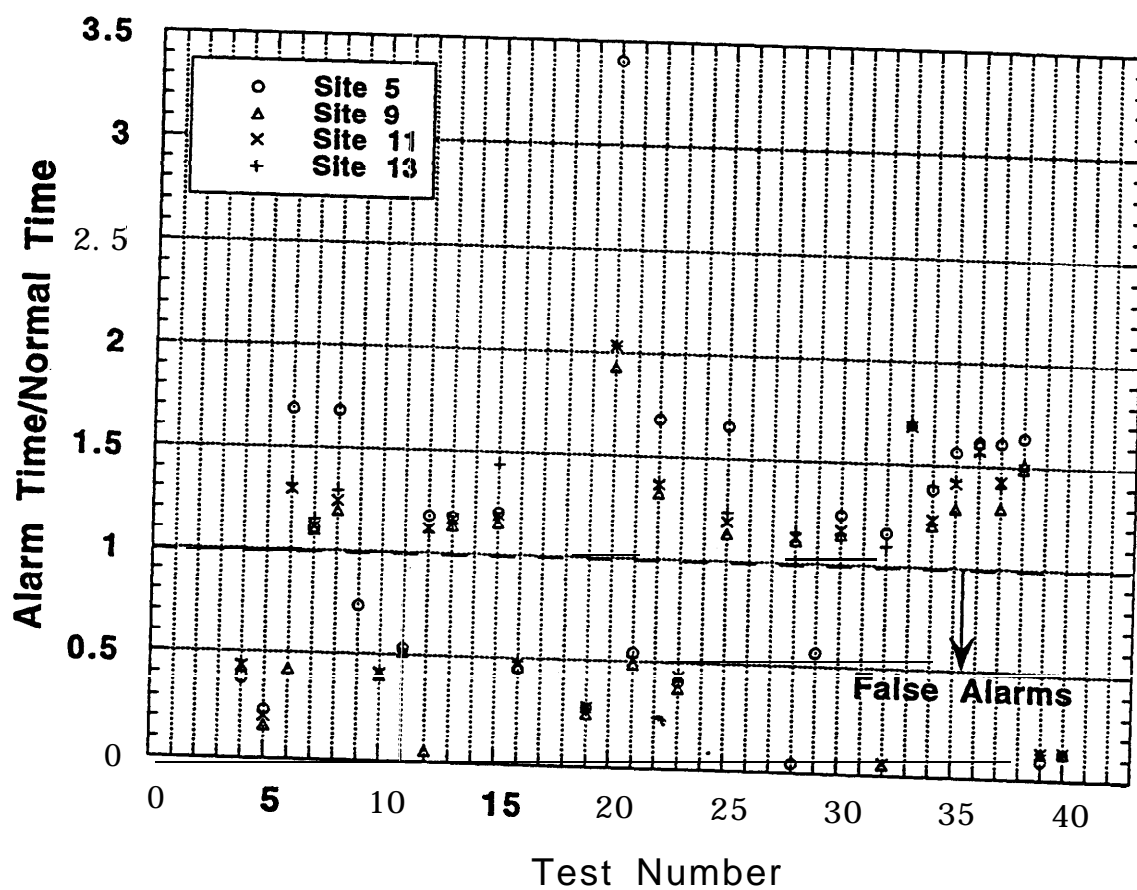
Figure 48. Sites 5-13 photoelectric smoke detectors ratio of alarm times to normal times for all tests versus test number.

Figure 48 shows the ratios of alarm times to normal times for the photoelectric detectors at sites 5-13 plotted versus test number. Data points are scattered on each side of the horizontal dashed line indicating a ratio value of one. Points falling below the line represent false alarms because the alarm time was less than the time of the end of the normal-cooking period. Points above the line represent acceptable alarms because they occurred after the normal portion of a test. Figure 49 shows the ratios of alarm times to ignition times versus test number for the same detectors. For this plot, points above the line **represent** failures to alarm because the **alarm** time was later than the ignition time. Points below the line represent successful alarming before ignition. Note that no cooling-lag time or safety margin was subtracted from the ignition times. Figures 50 and 51 are plots similar to Figures 48 and 49 except they pertain to the remaining photoelectric smoke detectors at sites 14-17.

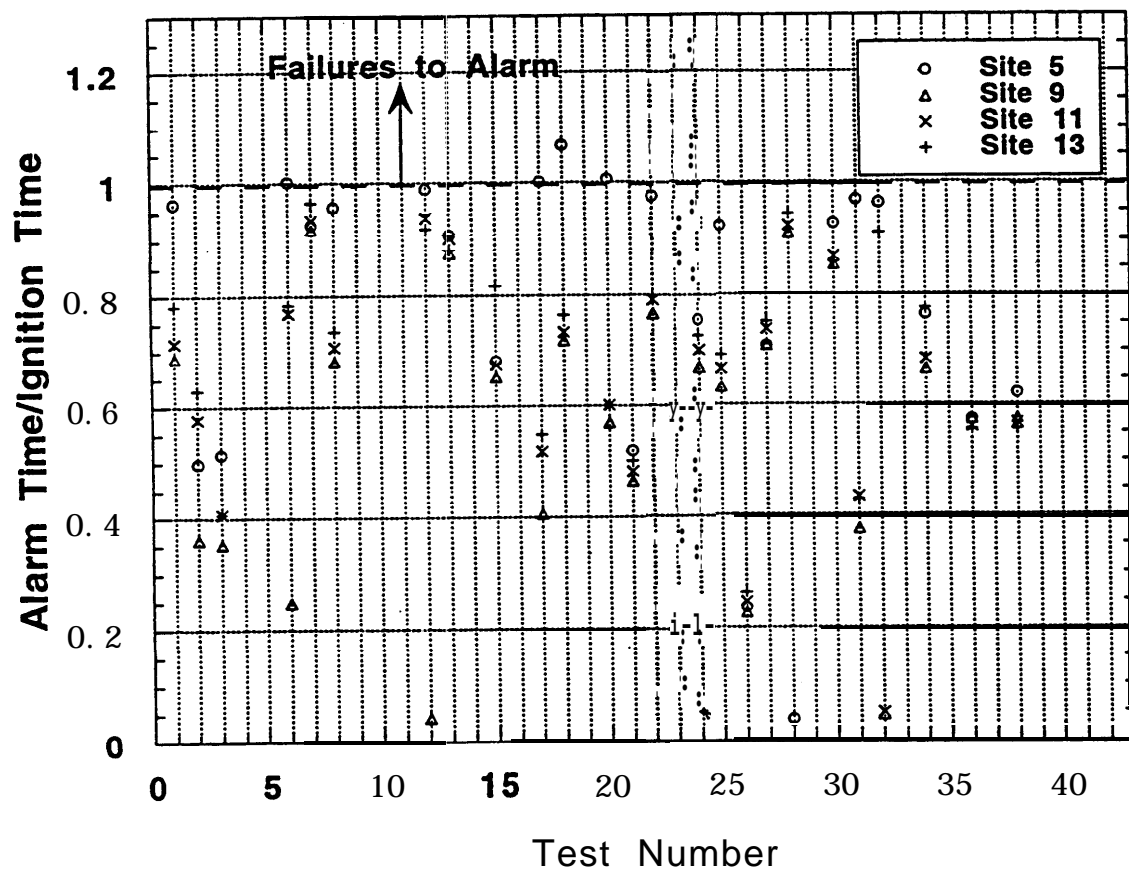
Figure 49. Sites 5-13 photoelectric smoke detectors ratio of alarm times to ignition times for all tests versus test number.

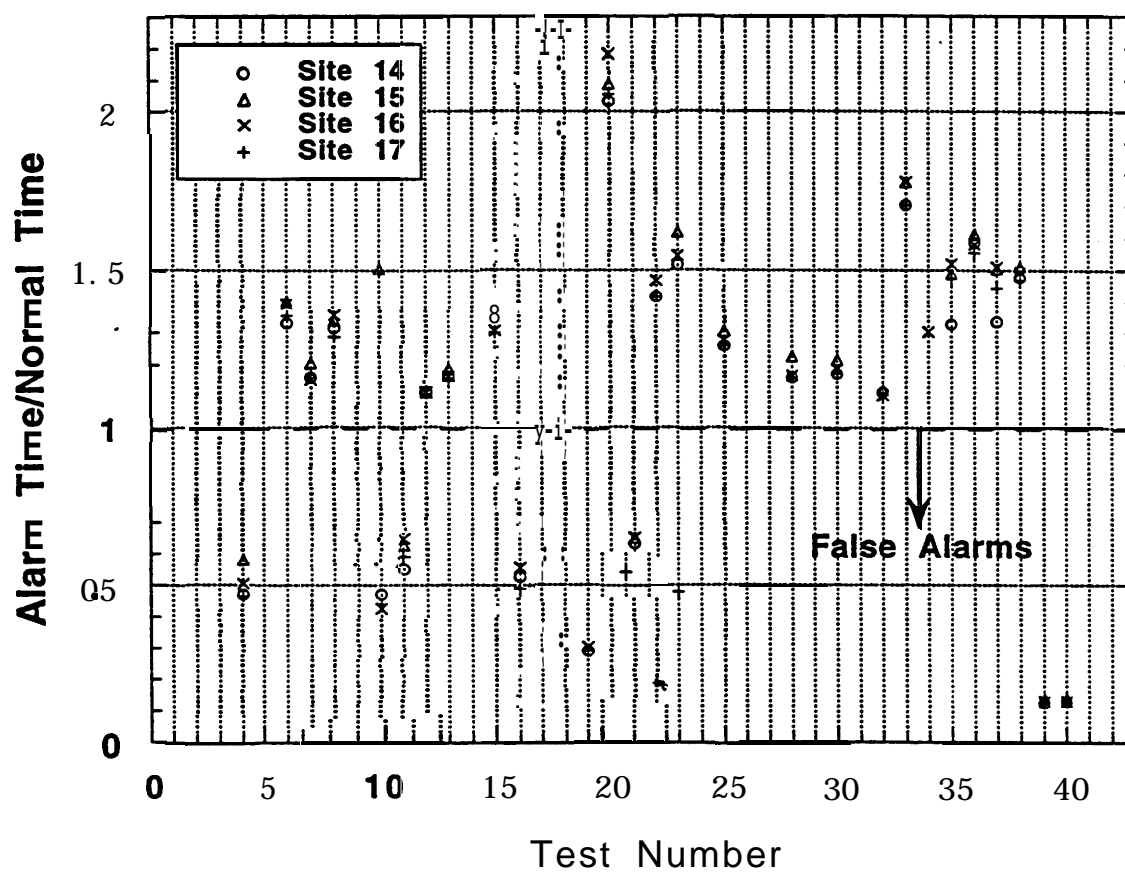
Figure 50. Sites 14-17 photoelectric smoke detectors ratio of alarm times to normal times for all tests versus test number.

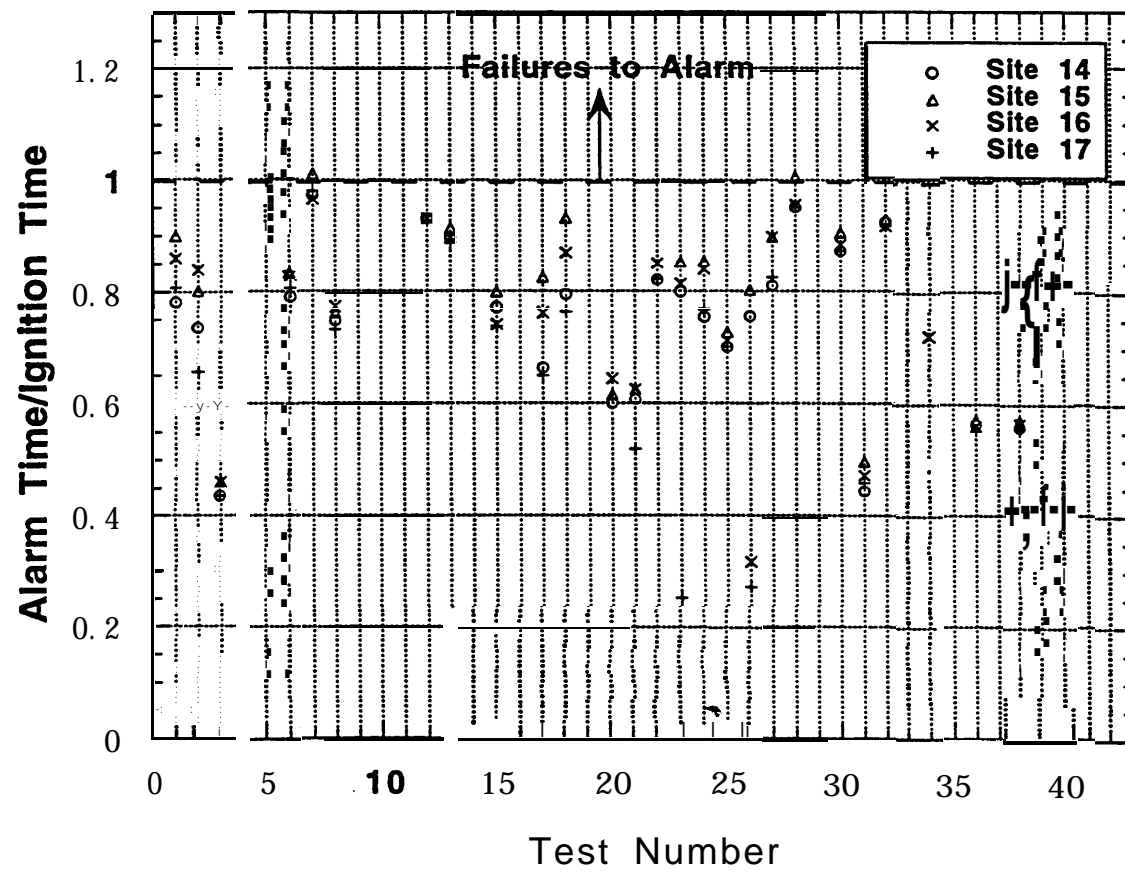
Figure 51. Sites 14-17 photoelectric smoke detectors ratio of alarm times to ignition times for all tests versus test number.

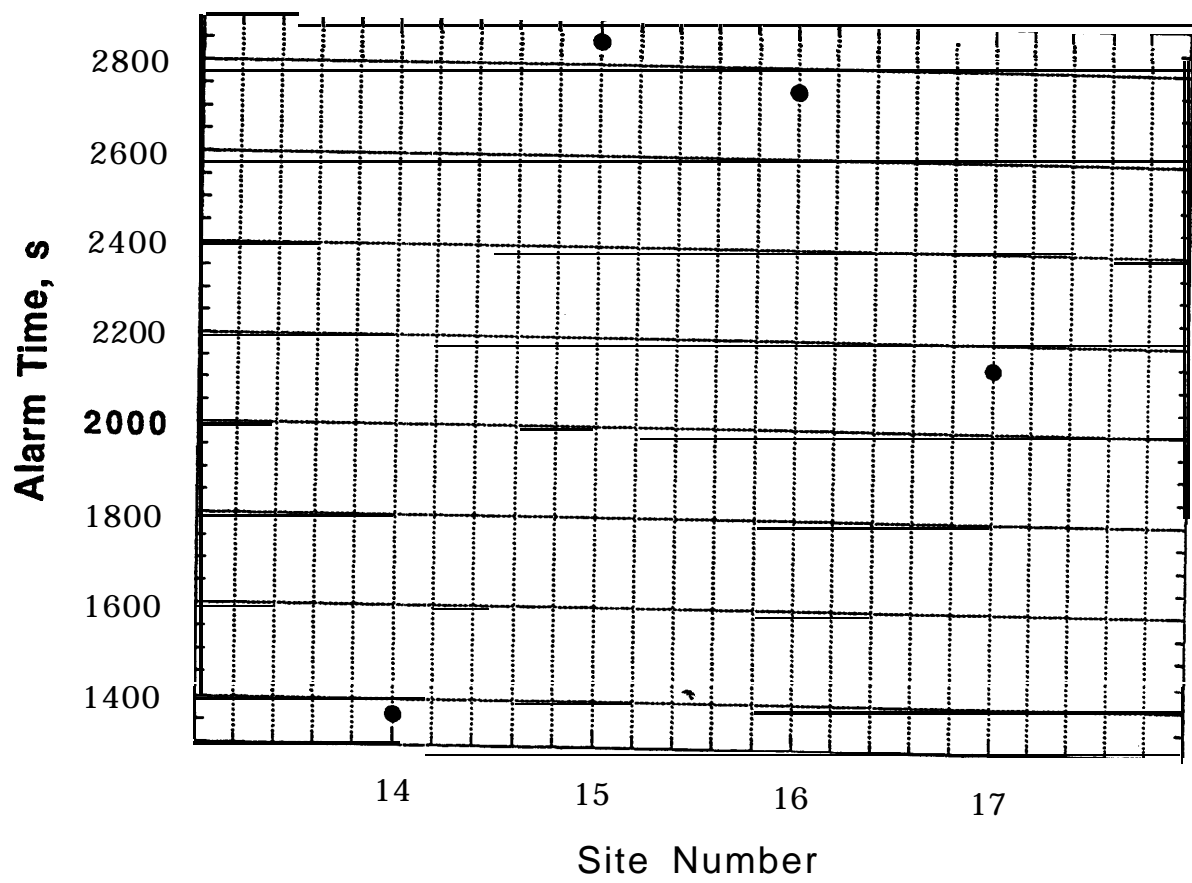
Figure 52. Average ionization smoke-detector alarm time for **all** tests versus site number.

Figure 52 is a plot of the alarm times for the various ionization detectors plotted in the same way as Figure 47 was for the photoelectric detectors. Four detectors were employed. Site 14 responded the earliest on average. Although it was not the closest to the range, it was located at the point where the accumulated smoke flowed out of the room into the exhaust hood. The site 17 detector was the next fastest and was the closest detector to the range. The detectors at sites 15 and 16 had comparable alarm times with those of site 15, again slightly slower in agreement with results for the photoelectric detectors.

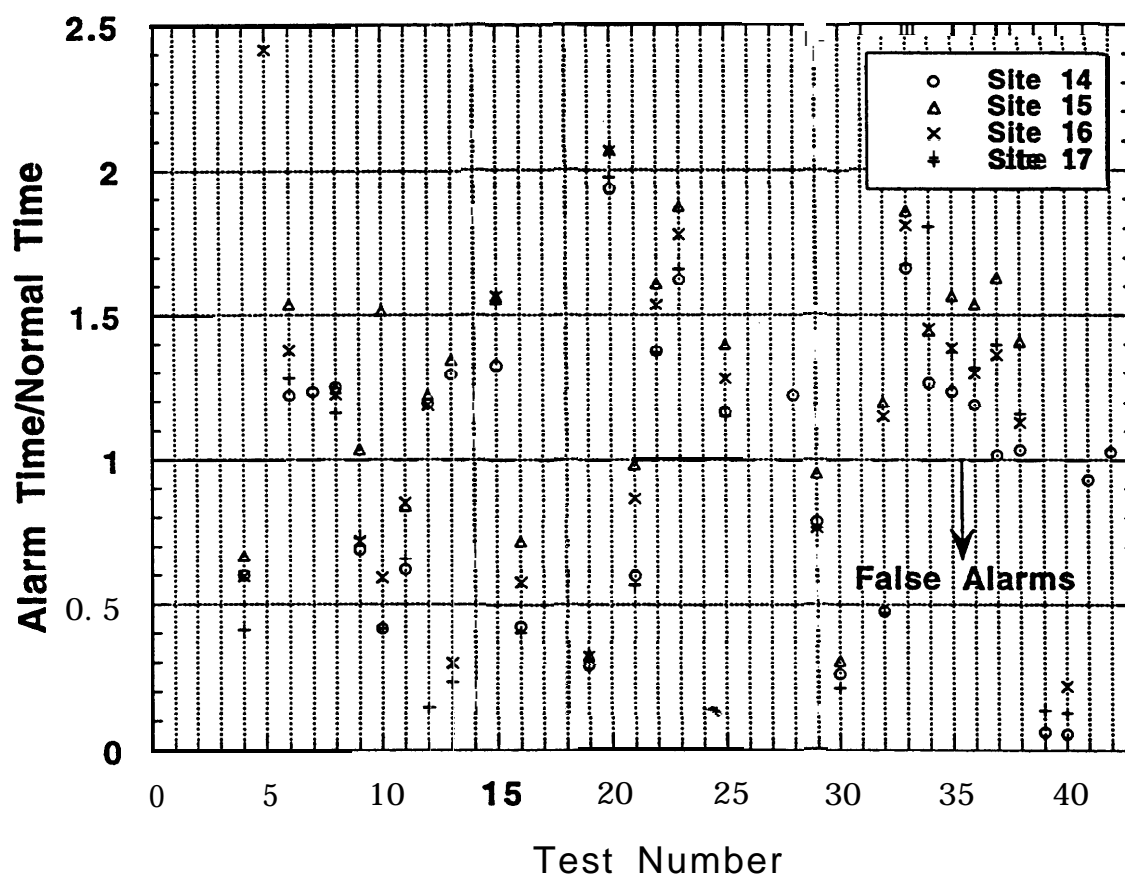
Figure 53. Sites 14-17 ionization smoke detectors ratio of alarm times to **normal** times for all tests versus test number.

Figure 53 shows the ratios of alarm times to normal times for the ionization detectors at sites 14-17 plotted versus test number. The data are plotted in the same manner as for the photoelectric detectors in Figures 48 and 50. Figure 54 shows the ratios of alarm times to ignition times versus test number for the same detectors. This plot is similar to Figures 49 and 51. Table 8 lists the ionization smoke detectors and their failure and success rates. Of the ionization detectors at sites 14-17, the one at site 15 failed most often to alarm before ignition which is the same result as for the photoelectric detectors. Similar to the relative success of the site 15 photoelectric detector, the site 15 ionization detector experienced the fewest false alarms of all of the ionization units. The detectors at sites 14 and 17 produced twice as many false alarms as the one at site 15.

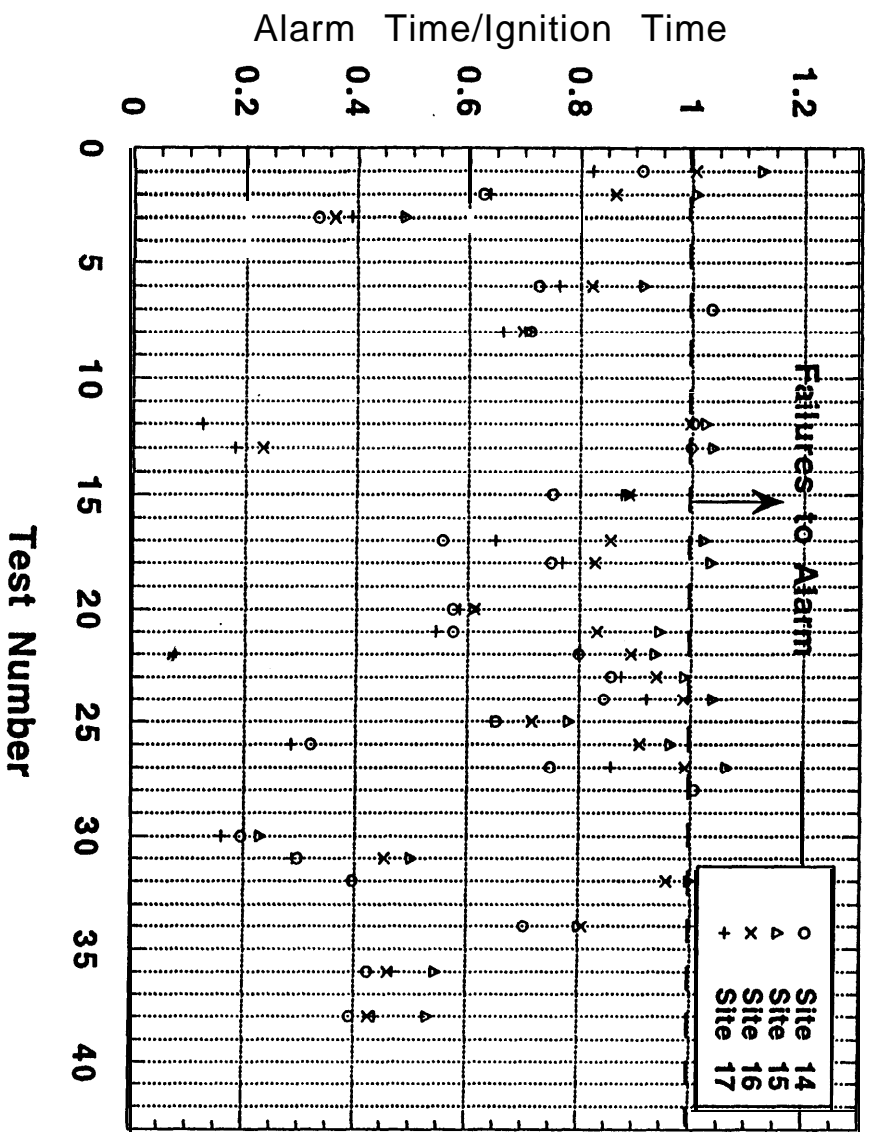
Figure 54. Sites 14-17 ionization smoke detectors ratio of alarm times to ignition times for all tests versus test number.
